| SUBJECT: <b>ALTERNATOR FR TERMINAL VOLTAGE<br/>— SERVICE MANUAL REVISION</b> | | | No: <b>TSB-05-13-006</b> |
| | | | DATE: <b>April, 2005</b> |

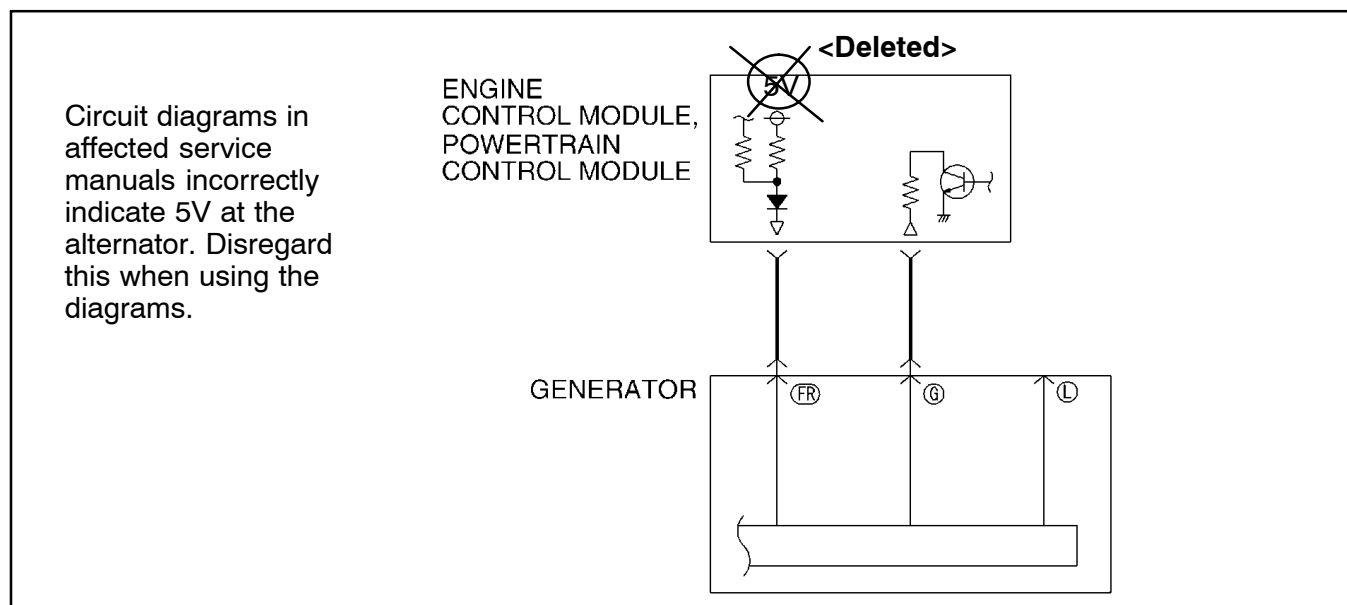
Some MFI diagnosis procedures include checking the voltage at the alternator FR terminal. The correct voltage reading between the alternator FR terminal and ground should be **battery positive voltage (12V)**. This is incorrectly specified in Group 13 of the affected service manuals.
